Best Management Practices for Controlling Erosion and Sedimentation During Electrical Transmission Line Construction on Steep Terrain

Maurice G. Cook¹ – James F. Hollifield²

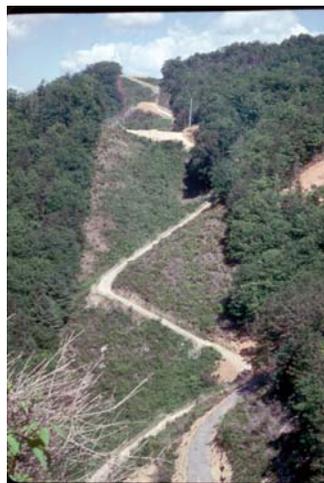
Figure 2 Typical access road on transmission line corridor

Many of the slopes for access roads to the tower sites exceed 25%. Furthermore, the width of the transmission line corridor is restricted in order to limit encroachment on national forest lands. This results in access roads with a steep ascent and numerous sharp “switchbacks” (Fig. 2). Consequently, providing logistical support, e.g., moving heavy equipment, hauling rocks, is slow and tedious on such roads.

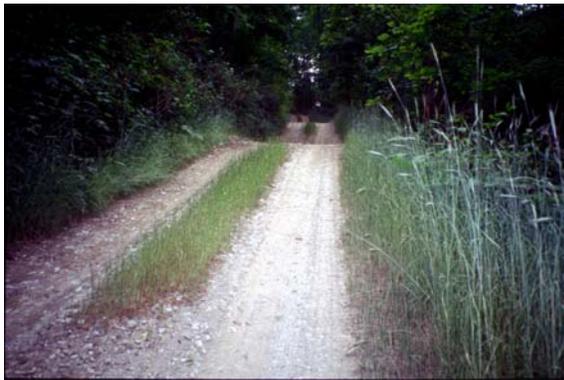
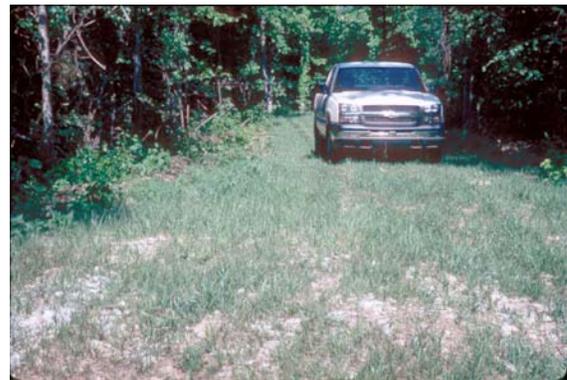
Figure 3 Excellent vegetative growth on road banks and access roads

There is considerable variation in the growth of the newly seeded vegetation due to differences in site condition, i. e., slope, soil, time of seeding, and microclimate. Seeding is occasionally required several times to obtain a stand. Growth is much better in cool, moist regimes along the line (Fig. 3).
